Revegetation of the McArthur River Diversion Channel

2006 - 2019

Christine Jones
Senior Environmental Advisor – Rehabilitation
McArthur River Mine

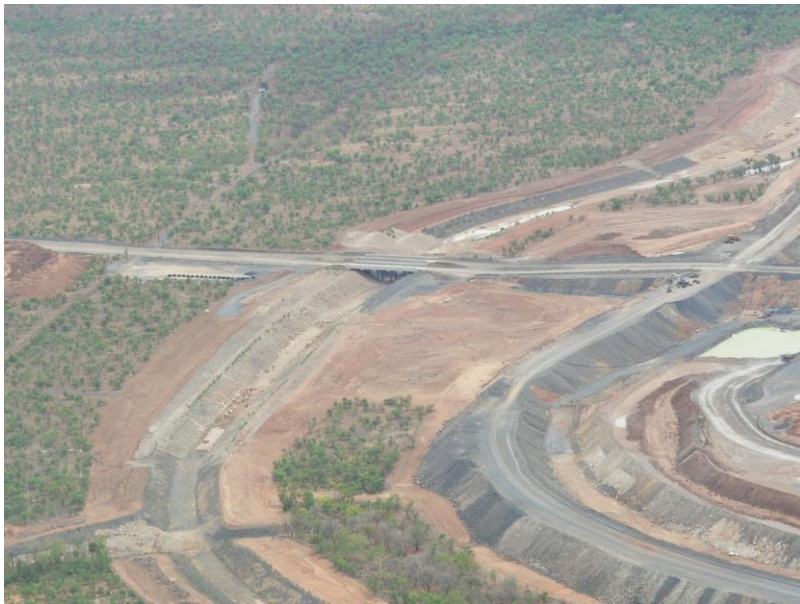
Barney Creek Diversion Channel - 2008

The Barney Creek Diversion Channel is located around the northern edge of the mine levee wall and directs flow from the northwest around to the northeast where it joins the original McArthur River Channel.

The Barney Creek Diversion Channel is approximately 3km long.

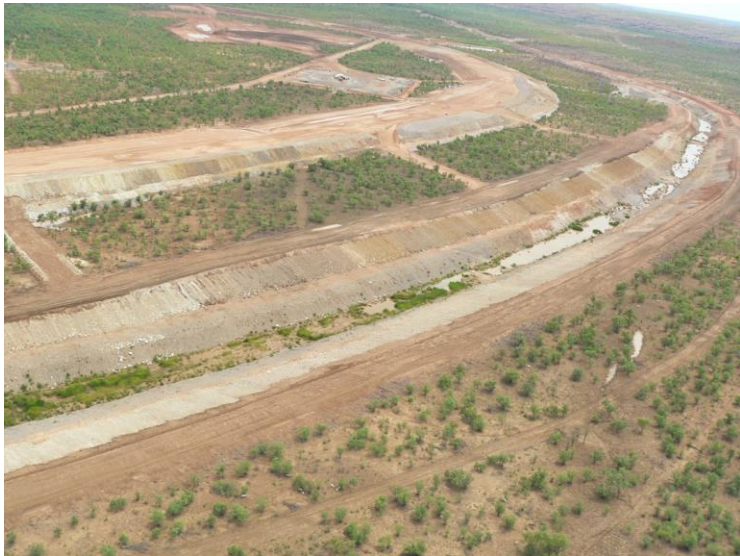
McArthur River Diversion Channel - 2008

The McArthur River Diversion Channel is located around the southern edge of the mine levee wall and directs flow from the southwest around to the southeast where it joins the original McArthur River Channel.

The McArthur River Diversion Channel is approximately 5.5km long.

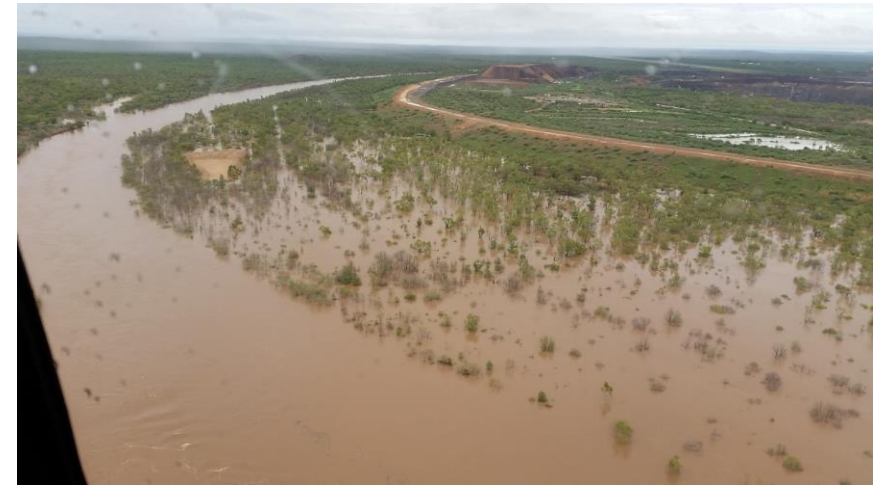
McArthur River – 2016 Wet Season

During Large Flood Events (1 % Annual Exceedance Probability)

- Barney Creek water flows between 4 m/s and 6 m/s
- McArthur River water flows between 2 m/s and 4 m/s

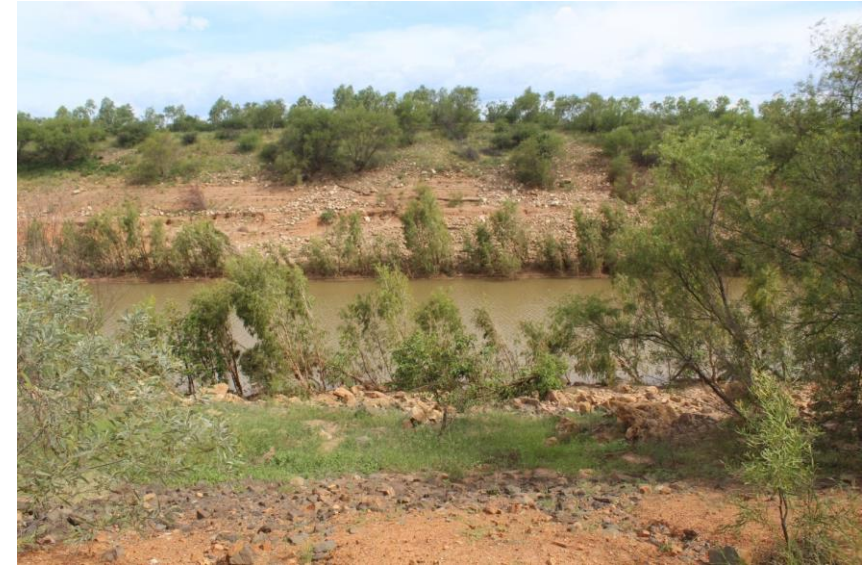
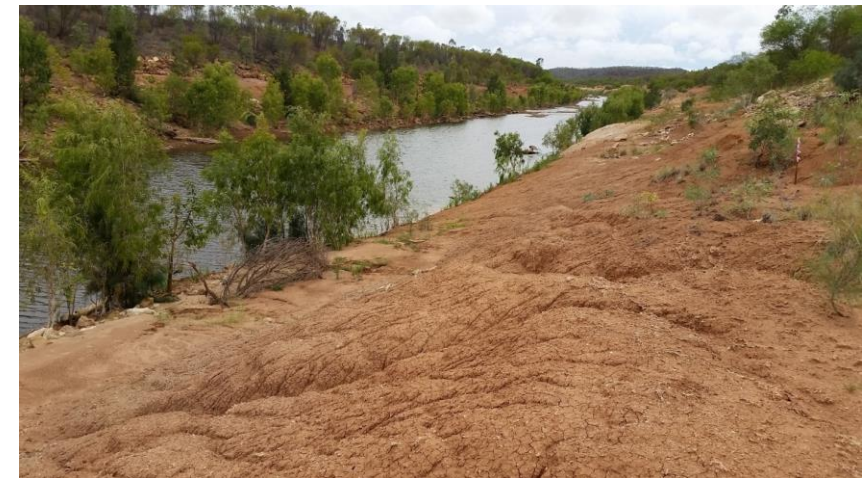
Growth Medium on the Diversion Channel

Clay dominant soils

Steep batters of Diversion Channel

Soil is highly erodible (Diversion Channel and natural soils)

Erosion due to surface water flow and rainfall

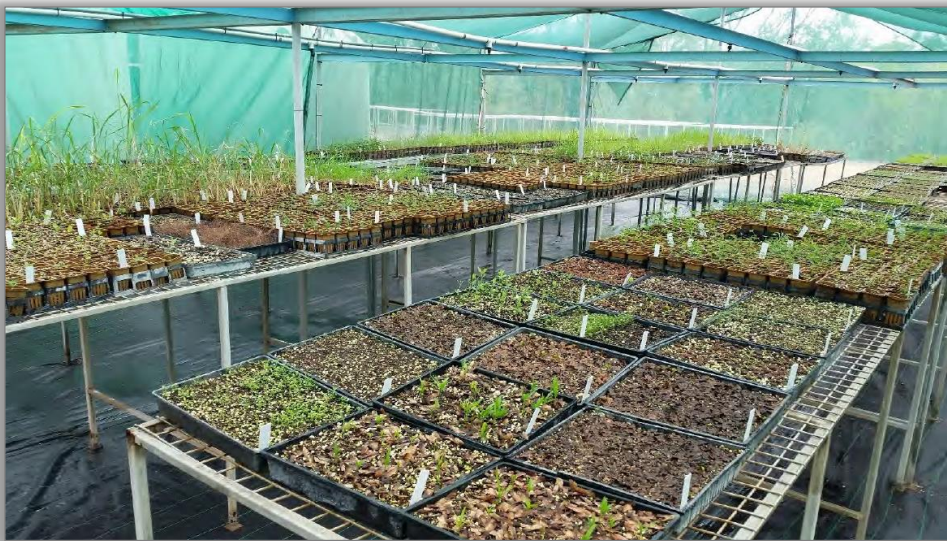
Seed propagation nursery (75% UV shade cloth)

- 80% of tubestock planted on the McArthur River Diversion Channel is sourced from seed collected from the local area and grown in MRM's dedicated onsite Nursery.
 - Exemplary of Glencore's leading industry approach to environmental management.
 - 3 shade houses and large hardening off area.
 - >120,000 tubestock capacity.

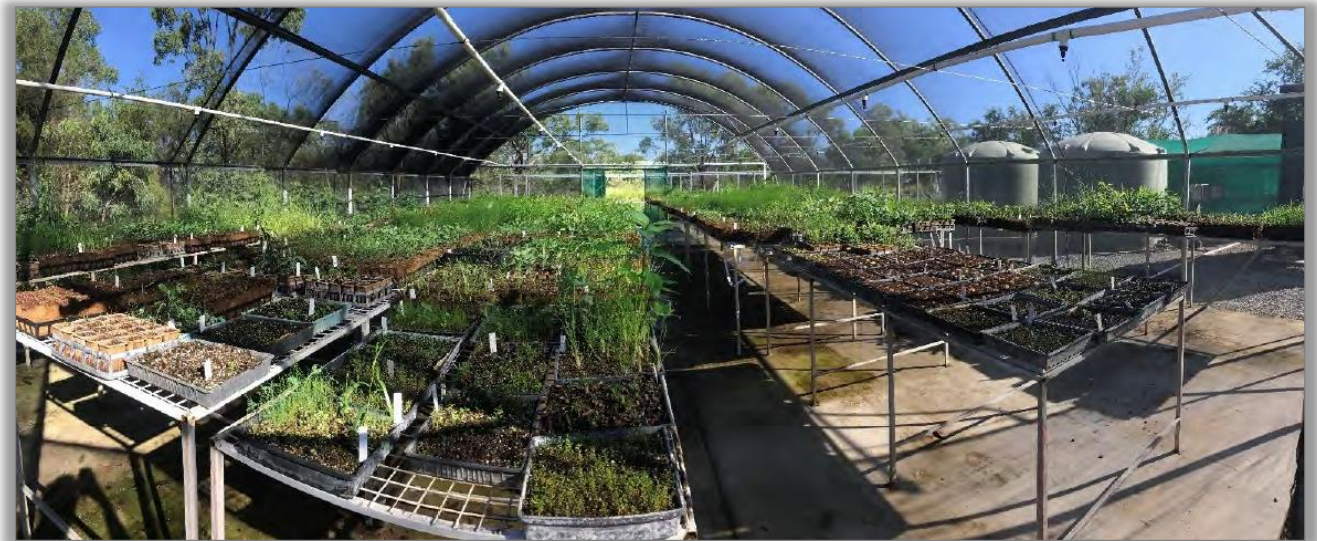
Tubestock propagation nursery (30% UV shade cloth)

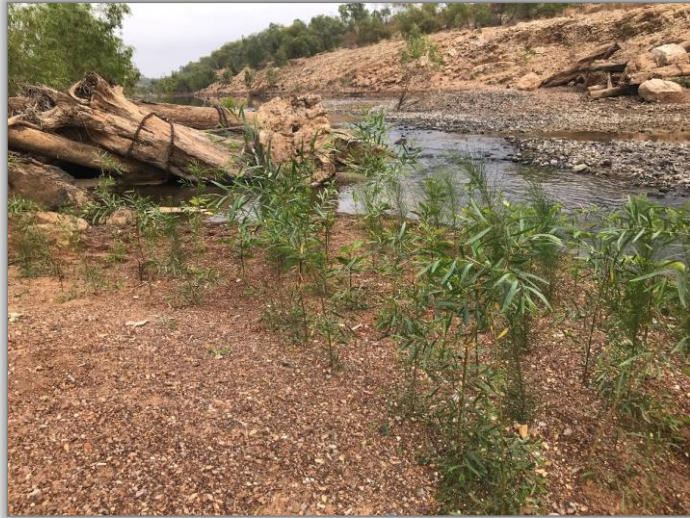
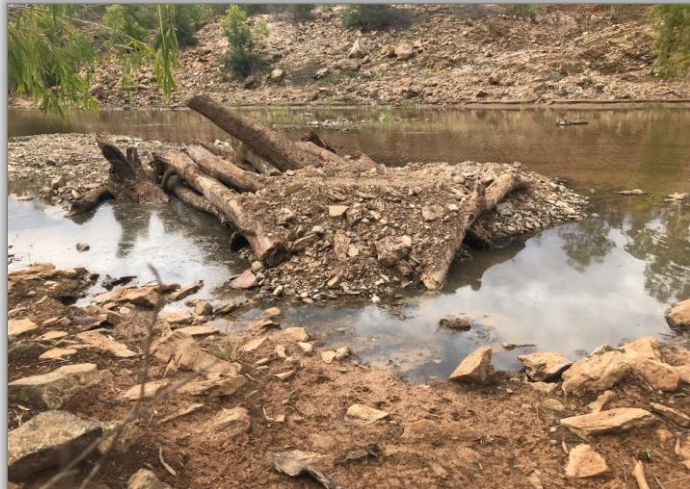
Large Woody Debris

The effective placement of large woody debris (sourced from approved clearing) within the Diversion Channel has been the single most effective action in providing fish habitat, with many other related benefits:

- Higher numbers of fish and increased diversity recorded at sites with large woody debris
- Aids in fish migration via 'stepping stones', to provide respite from stream flow
- Alleviates scouring of the Diversion Channel
- Acts as a source of carbon
- Creates variation in flow and micro-habitat
- Improves stream bank stability

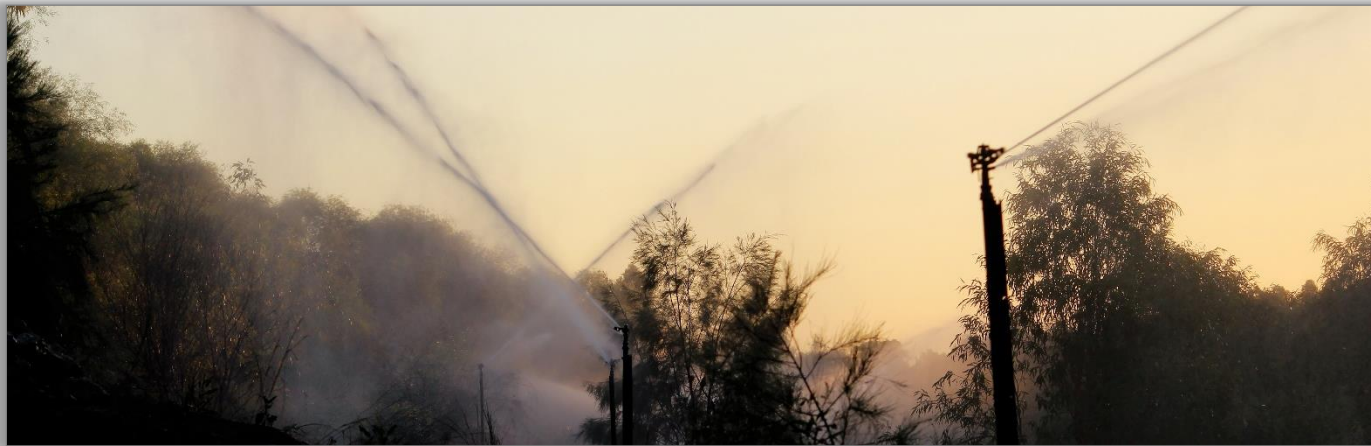
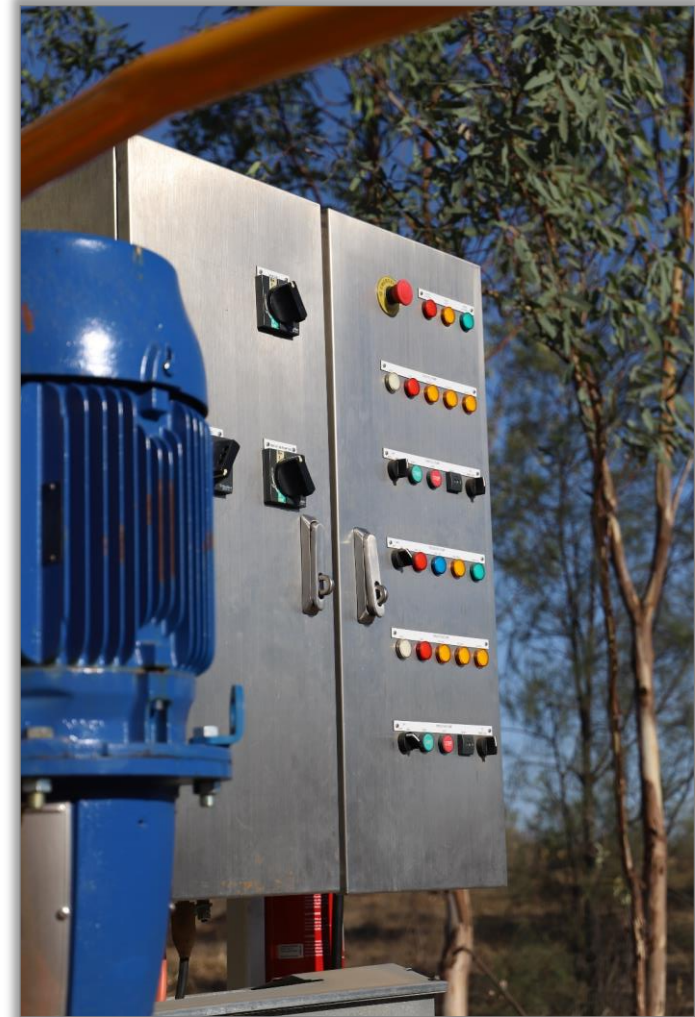
Revegetation Irrigation System

- A dedicated irrigation system supplies water to plants within the Diversion Channel during the dry season, improving survival rates and guiding revegetation success.
- Water is sourced from a licensed extraction bore to supply the two irrigation sleds and water tanks on the Diversion Channel.
- A total of 6km of irrigation pipework has been installed in 2018 - 2019.
